An Arboricultural Report on a Tulip Tree on land owned by 'The Blue Dolphin'

Kingston,

Devon

Date of site inspection: 19th June 2024

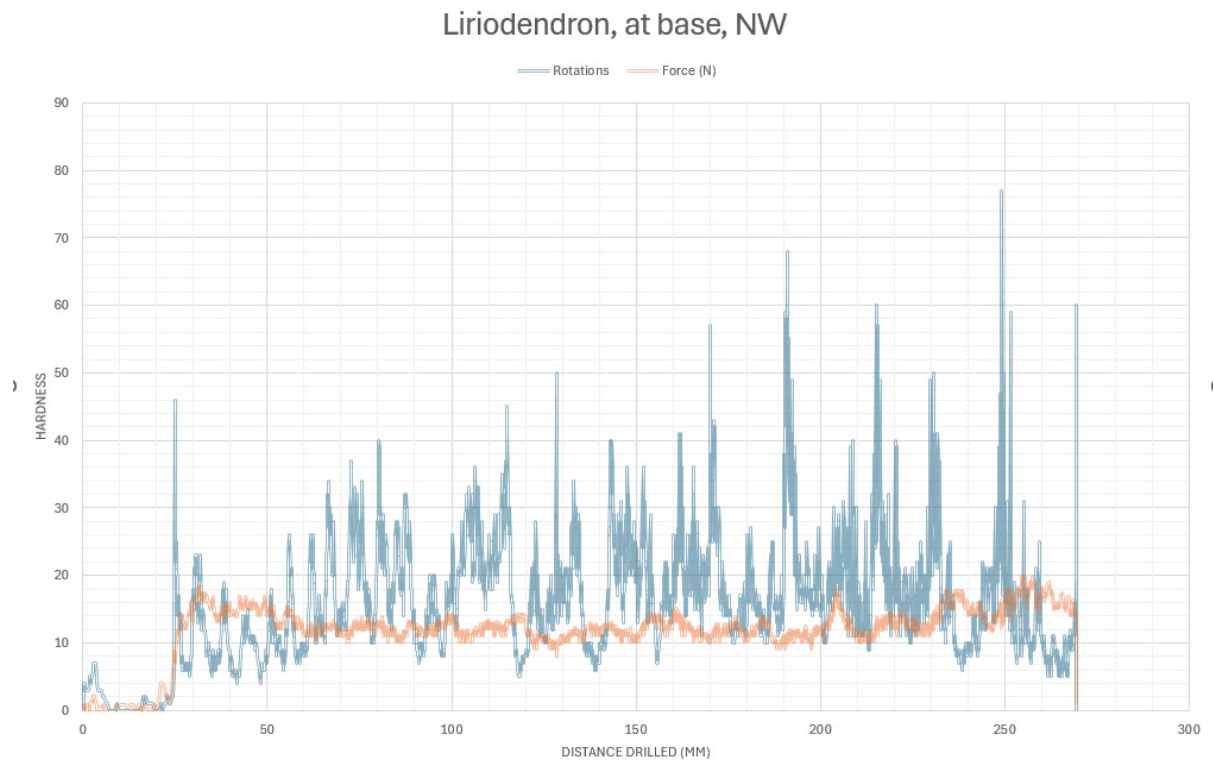
Drilling graph taken at base, NW side

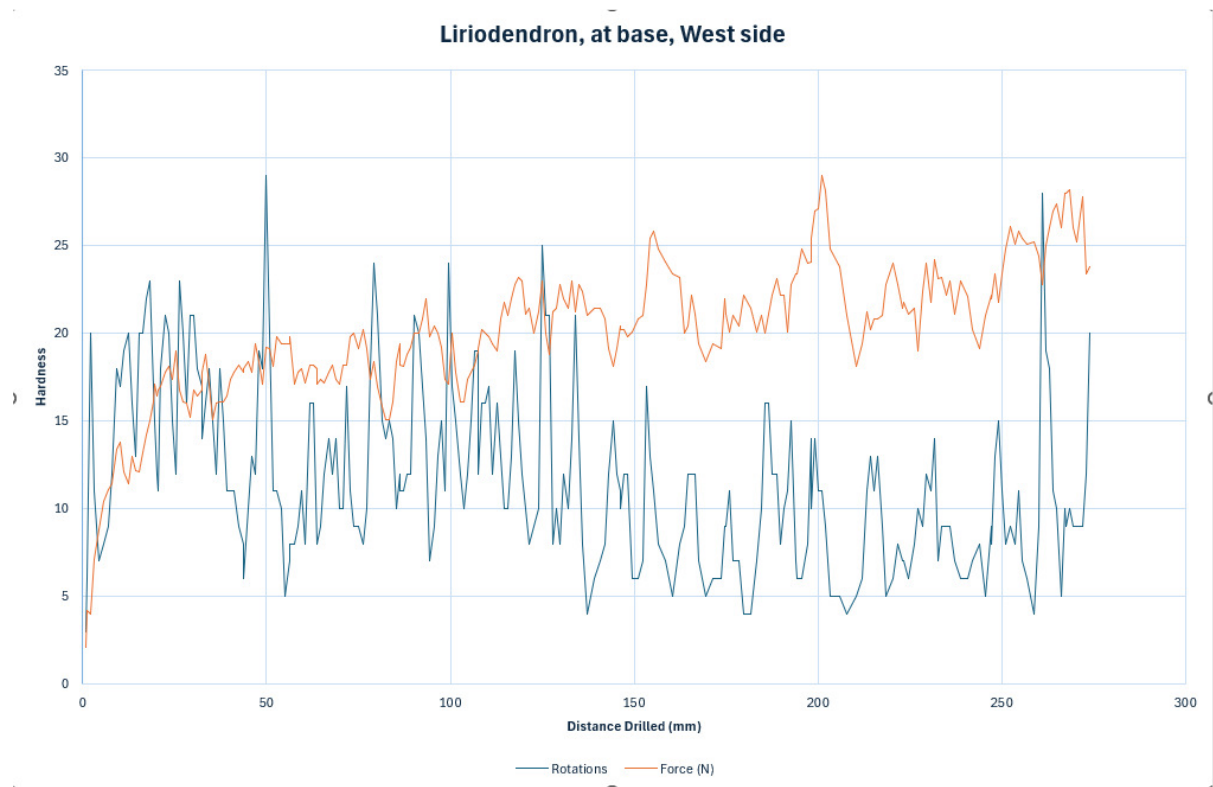
Drilling graph base on west side into dead area

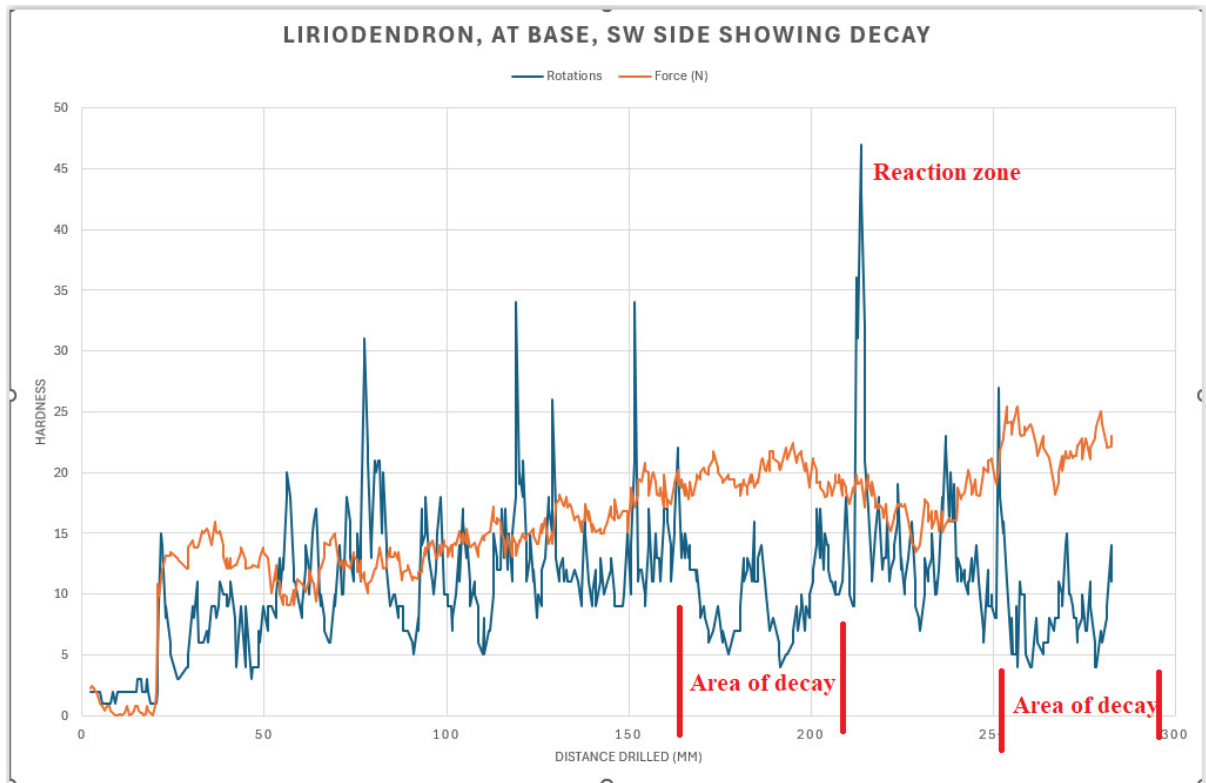
Drilling graph base, SW side, showing areas of decay, with a clear reaction zone

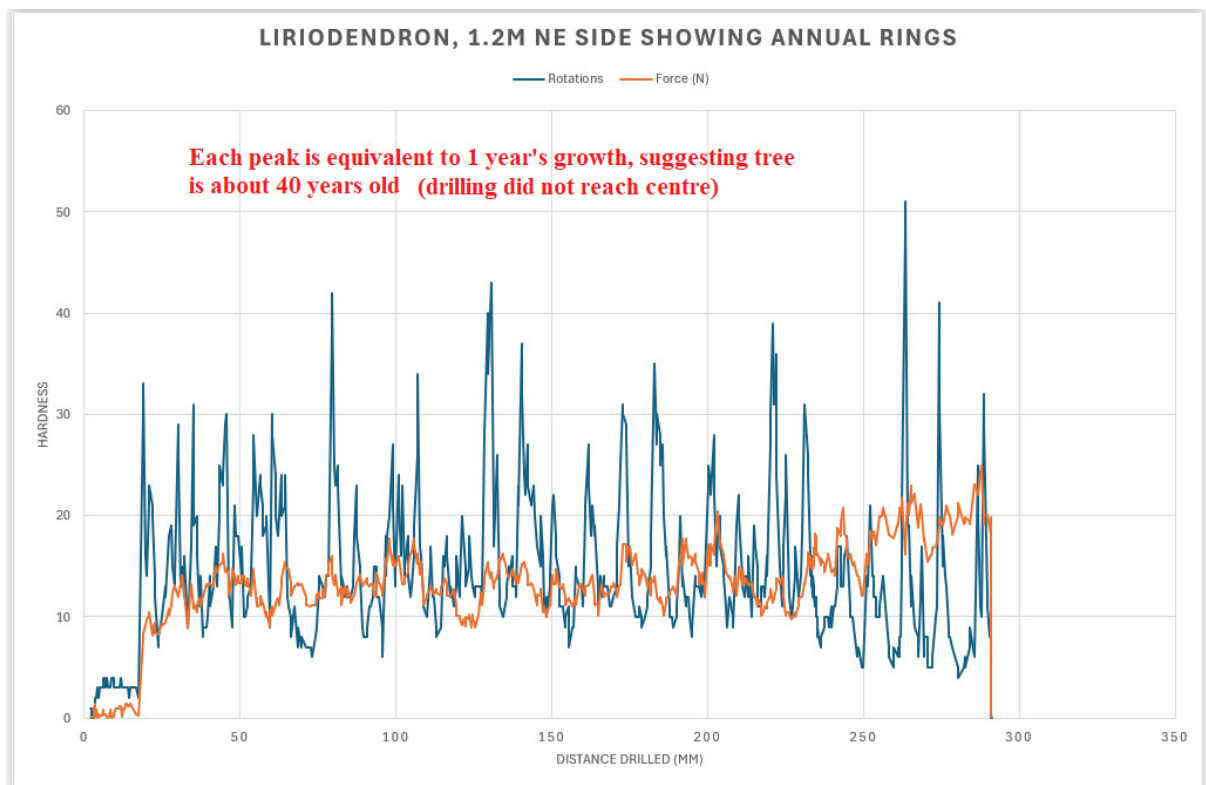
Drilling graph, 1.2m up on NE side showing annual growth rings
